GILA RIVER BASIN NEW RIVER AND PHOENIX CITY STREAMS, ARIZONA MARICOPA COUNTY, ARIZONA

CAVE BUTTES DAM FOUNDATION REPORT

U.S. ARMY, CORPS OF ENGINEERS

AUGUST 1983

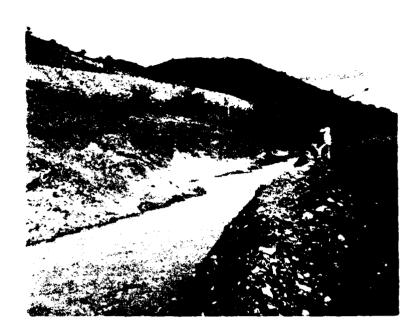
Photo 3 Diversion of water through construction, toe of right abutment, upstream of center-line of dam.

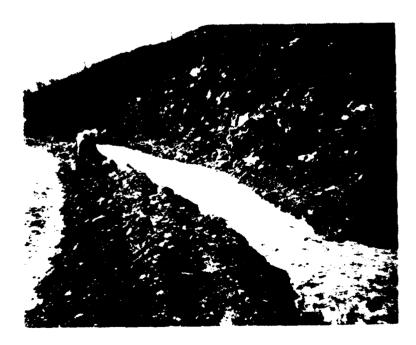
Photo 4 Diversion of water through construction, toe of right abutment, downstream of centerline of dam.

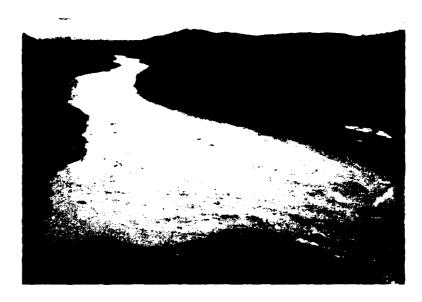
Photo 5 Diversion of 1500 cfs along toe of right abutment. View is up channel to the north. $2~{\rm Mar}~78$

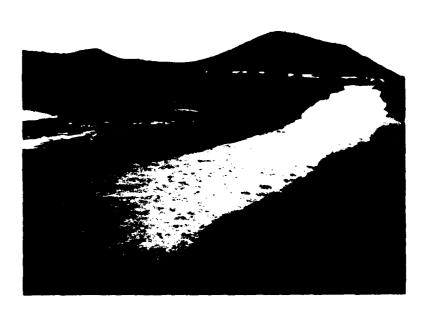
Photo 6 Diversion of 1500 cfs along toe of right abutment. View is down channel to the south.

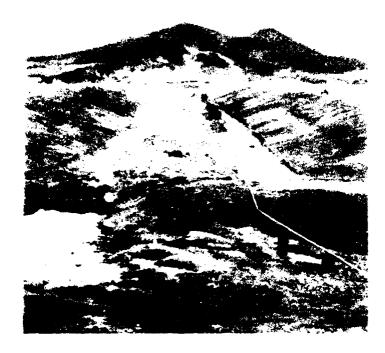
Photo 7

Core trench. Looking east from top of diversion dike. Contractor trying to remove water from trench.

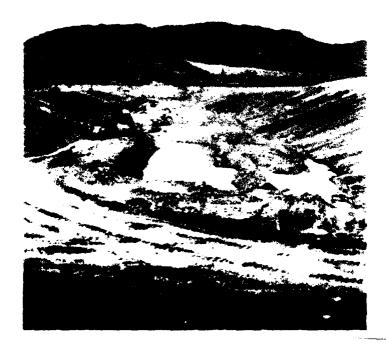
Photo 8

Core trench. Looking west. Contractor trying to drain water accumulated from rain and seepage.

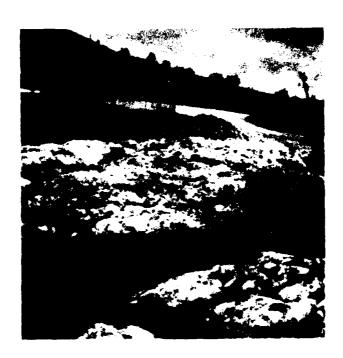
Photo 10

Seep in bottom of cutoff trench at rock knob, Sta. 27+50.

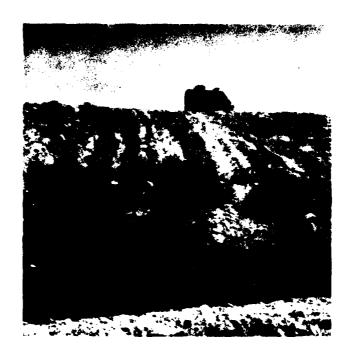
Photo 11

Downstream side of cutoff trench, Sta. 21+05. Salt cedar growth along seepage at top of bedrock.

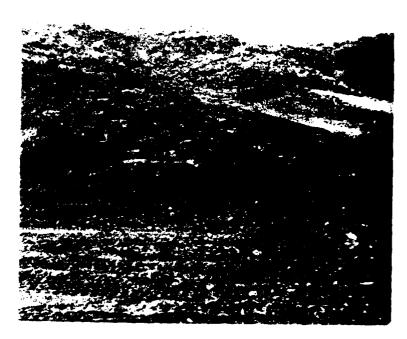
Photo 18 Right abutment. View looking west during early stage of cleaning operations.

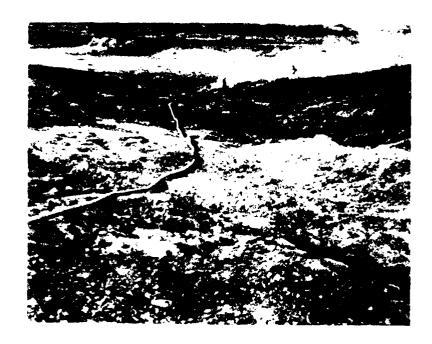
Photo 19 Left abutment. Approximate centerline of zone I foundation from near top of dam.

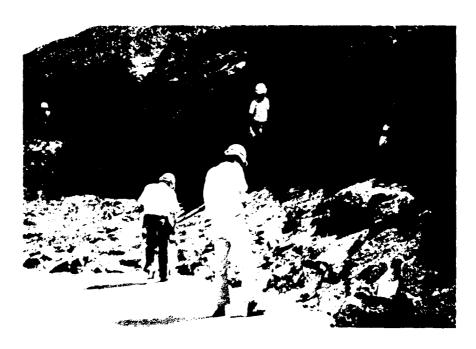
Photo 39 Outlet Works. Portion of concrete backfill near Sta. 50+00 to restore proposed foundation grade.

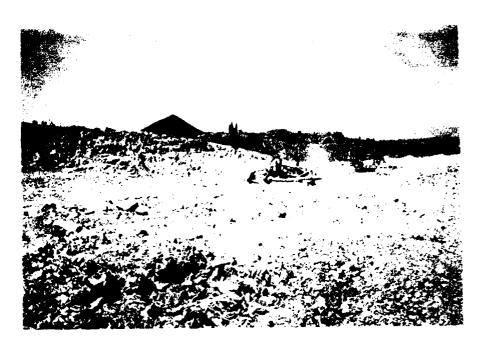
Photo 46

Dike No. 2.
Right side after excavation half way up abutment.

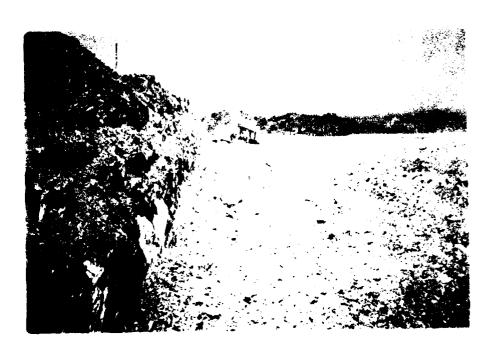
Photo 47 Spillway. Upstream right (west) side. Excavation by ripping with localized blasting.

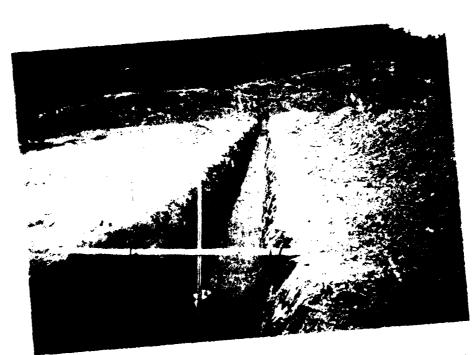
Spillway. Final cut. Split spacing drilled on 1-foot centers.

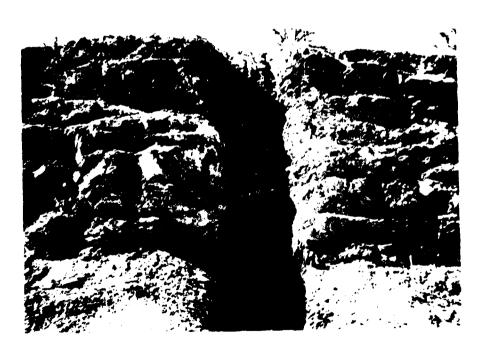
Photo 53 Spillway crest. Left (east) wall after cleaning to remove loose rock; overbreak is at notch for vertical extension of sill.

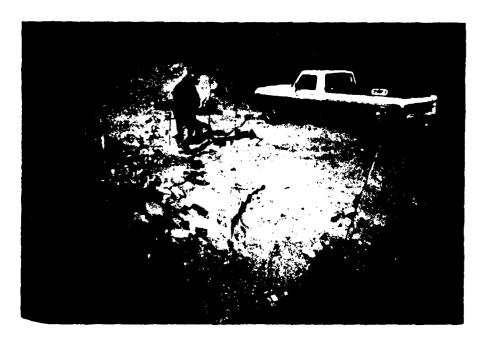
Photo 55 Spillway crest, Sta. 18+00. Drilling holes 5 feet deep on 1-foot centers for controlled blasting of sill trench.

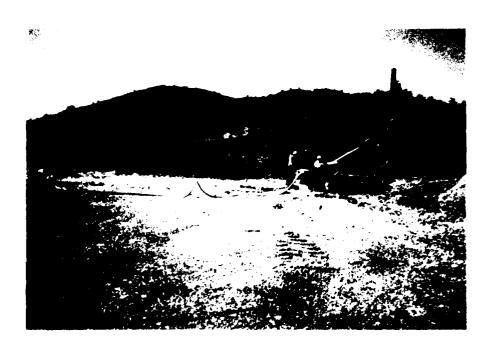
Photo 57 Bypass channel. View looking upstream. 13 July 79

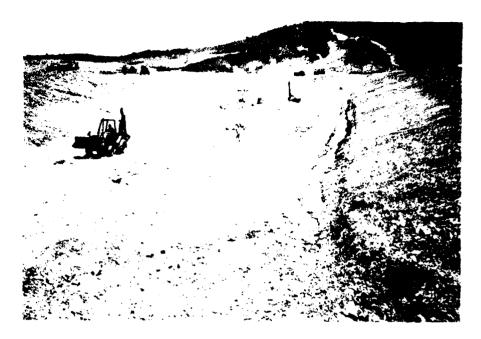
Photo 62

Right abutment. Drilling grout holes.

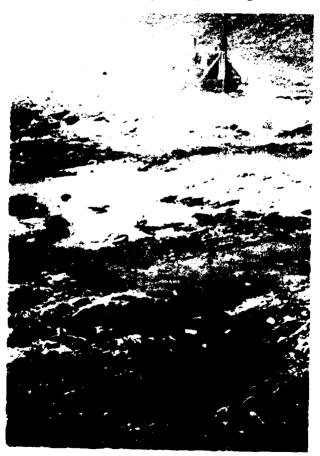
Photo 63 Cutoff trench. View east toward left abutment. Clean up and grouting in bottom of trench.

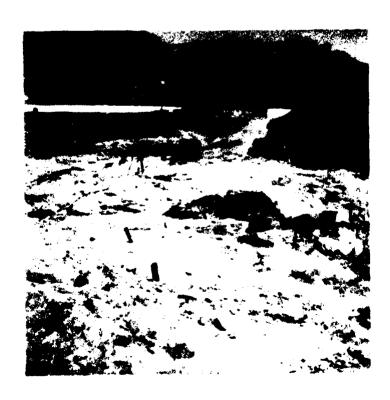
Photo 67 Cutoff trench. Dental concrete on upstream side between Stas. 18+50 and 20+00.

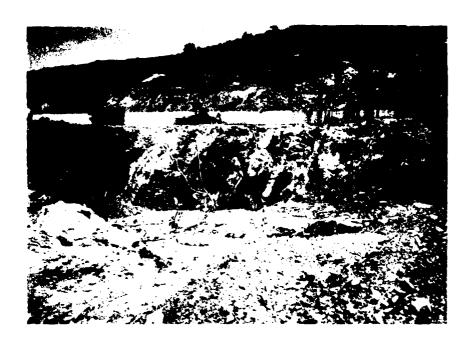
Photo 68

Cutoff trench.
Dental concrete at
Sta. 24+82, downstream from grout
curtain.

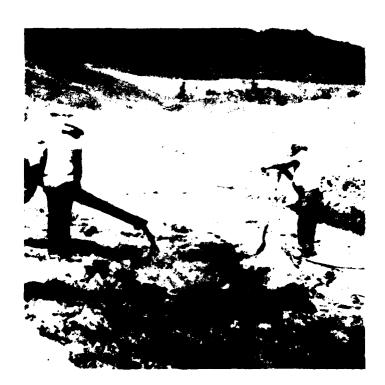
Photo 69 Cutoff trench. Grouting to cut off seepage at Sta. 28+50.

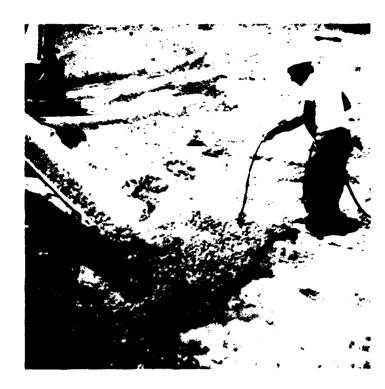
Photo 70

Cutoff trench. Placing dental concrete.

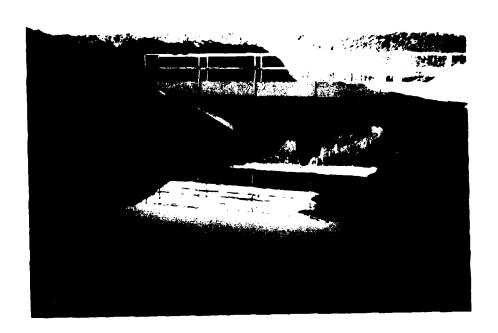
Photo 83 Left abutment after cleaning and during grouting. 8 Aug 78

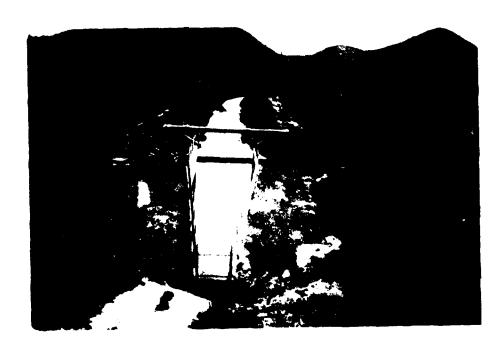
Photo 84 Outlet channel. View upstream toward beginning of of channel. Footbridge, energy dissipator and skyline of embankment at elevation 1,595.

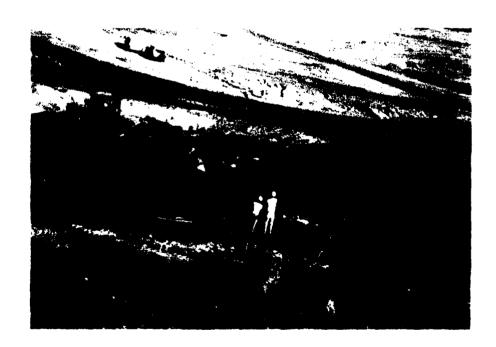
Photo 88 Dike No. 2. Elevation 1,650, west abutment. View looking east. 7 May 79
